**A PRELIMINARY INVESTIGATION
REGARDING
THE DESIGNATION
OF
A PROPOSED AREA IN NEED OF
REDEVELOPMENT**

***THE ROUTE 23
REDEVELOPMENT
AREA***

PREPARED BY:
THE NELSON CONSULTING GROUP
2 VOLCANIC HILL ROAD
WANTAGE, NEW JERSEY
973 875 8685

APRIL 30 ,2015

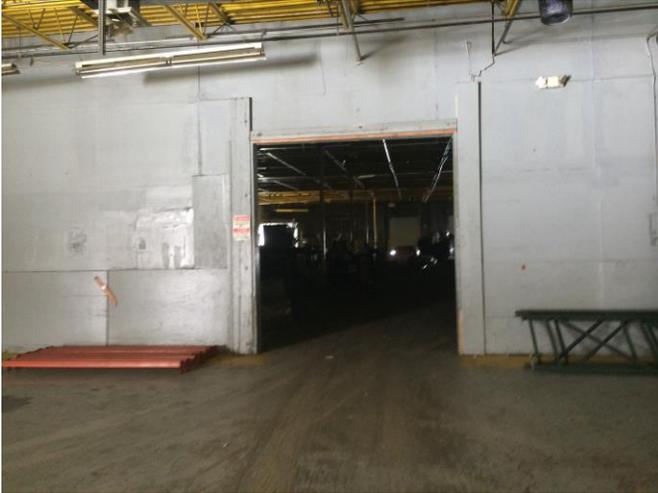
1

- There is inefficient lighting in the warehouse area, which could create dangerous working conditions (photo 1)
- Deteriorated and damaged facilities exist in the office areas of the building (photo 7)

- The building floor area is divided into a half dozen spaces and there are inadequately sized connections between those spaces. There are also support pillars spaced closely together throughout the building. These conditions would make the operational activities for most industrial operations more inefficient than desirable (photo 1, 3 & 9)

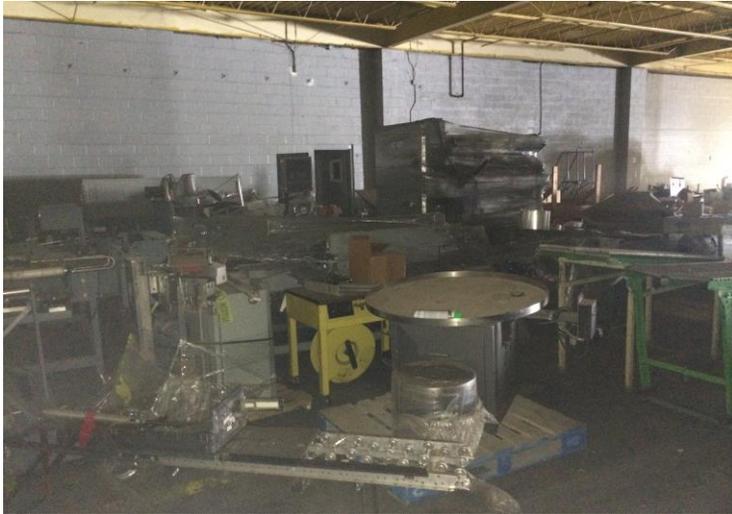
3

- Unsafe and unsanitary conditions exist and there is an indication that some mold conditions may also be present (photos 7 & 9)
- At the time of the inspection several areas contained abandoned machinery and equipment (photo 3)

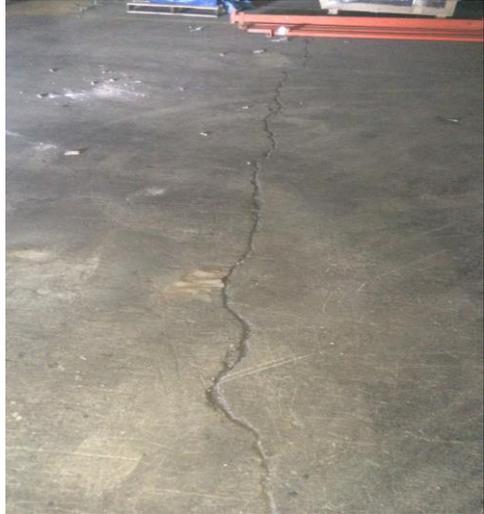
- There is a lack of insulation throughout the building and there is also a presence of asbestos (photo 9)
- There is a general lack of maintenance that is noticeable and needed repairs have not been done. There are indications that the roof is leaking and water damage has occurred, based on plastic sheeting that was observed hanging from the ceiling and a visual inspection of the walls and ceiling conditions at several locations in the building. The type of roof design and materials associated with the roof of this building are prone to settlement thereby leading to water from the roof infiltrating the building from above. The corrugated metal / tar roof would require substantial repair or replacement in order to correct the water damage problems (photos 4 & 5)

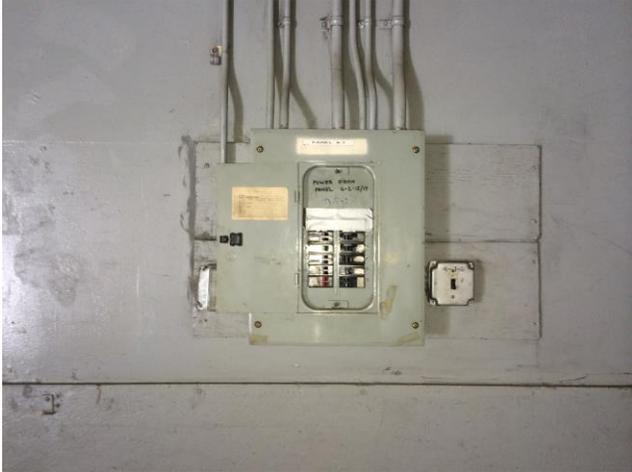
6

- A substandard / antiquated fire suppression system exists that is in need of replacement and upgrading (photo 8)
- The electrical system is substandard based on current code requirements (photo 6)

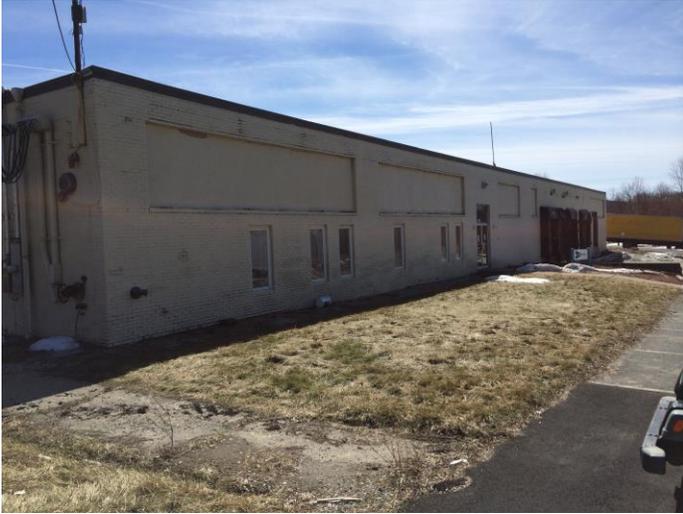
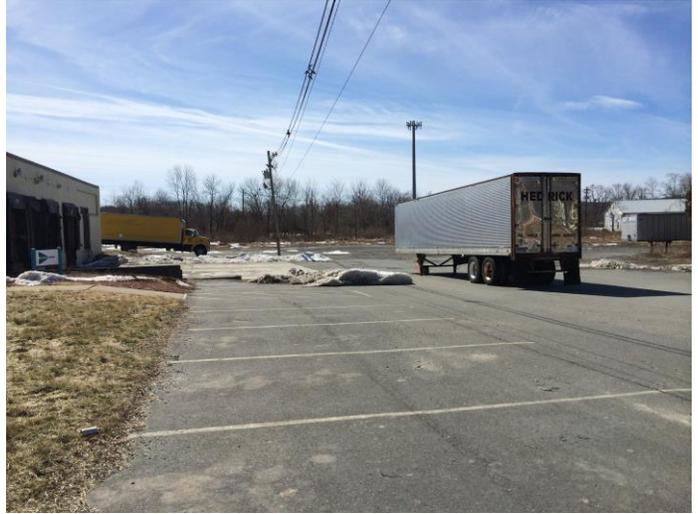
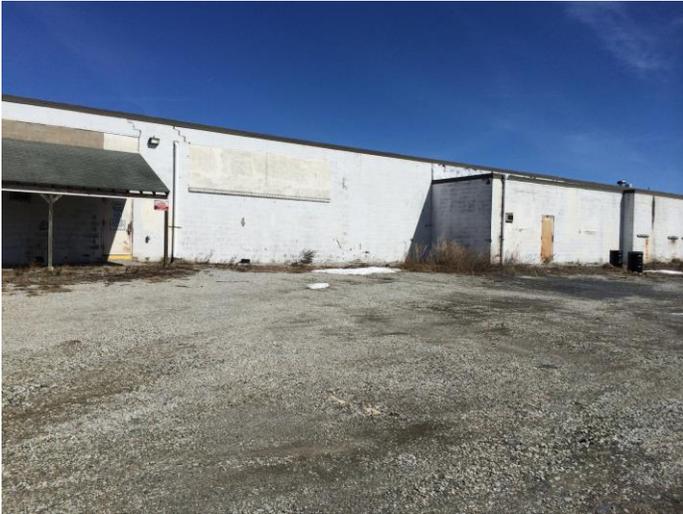
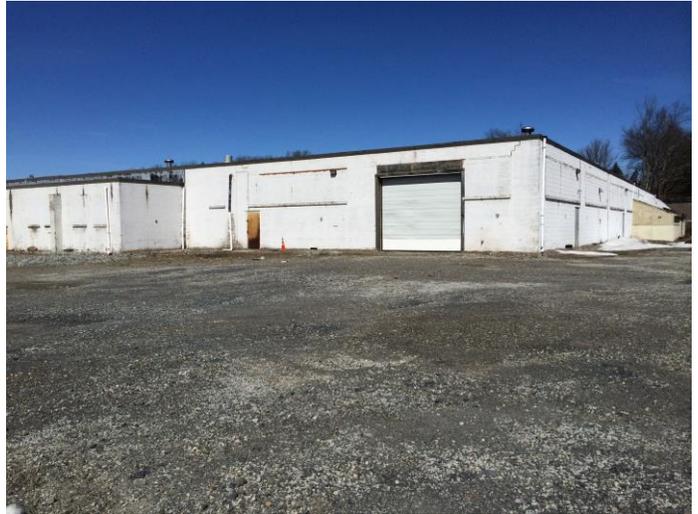
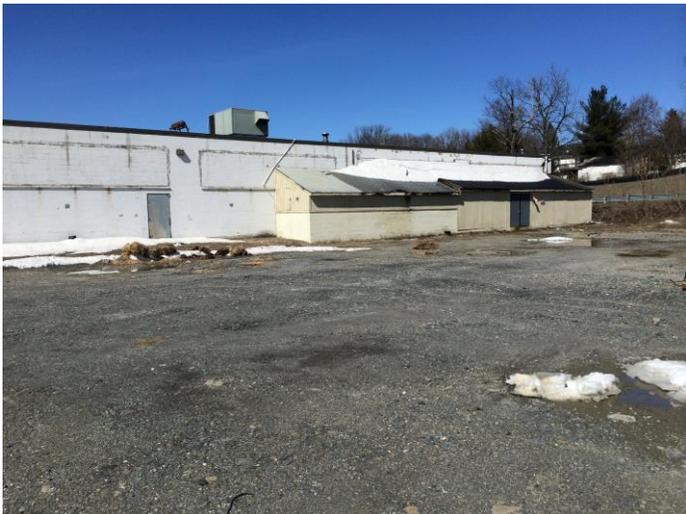
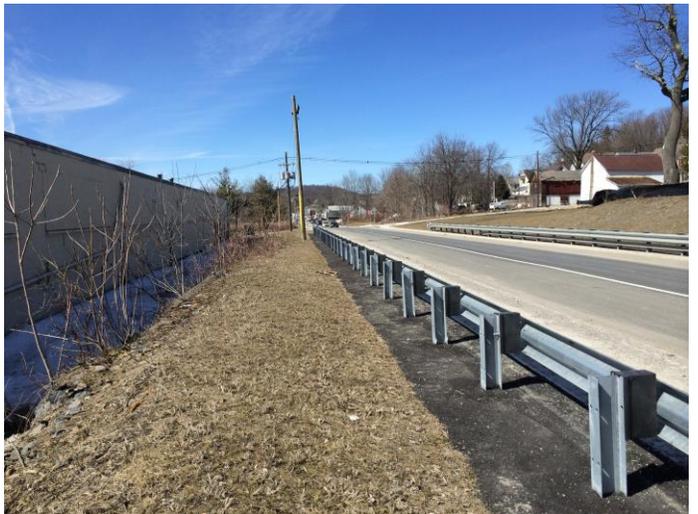
Photos 1 to 6 depict the four façades of the building and the areas immediately adjacent to the building, as seen approximately from the north (photos 1 & 2), west (photos 3 & 4), south (photo 5) and east (photo 6). In addition, photo 6 depicts the location of the building in proximity to the new Route 23 Southbound, as it passes the site. A detailed description of the building exterior will be presented in the following pages

The building is also deteriorating in certain locations and several parts of the building facades have been inappropriately altered with additions and alterations, which convey a sense of there having been little interest in the aesthetic features of the structure. But even those exterior sections of the building that have been reasonably maintained (i.e. the north side) are not attractive either and they visibly illustrate the antiquated design and excessive age of the building. It's obvious that not much thought went into the building design originally, because there was not much reason to do so, given the nature of the use of the building and its location. This was of little or no concern when the building was essentially hidden from public view. However, now that Route 23 Southbound passes by just several feet from the building, this is now a negative factor, which does not favor retaining the building as it currently exists.

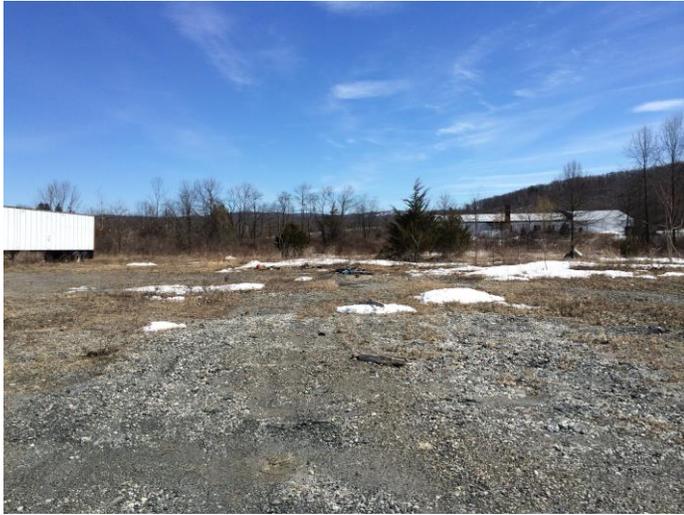
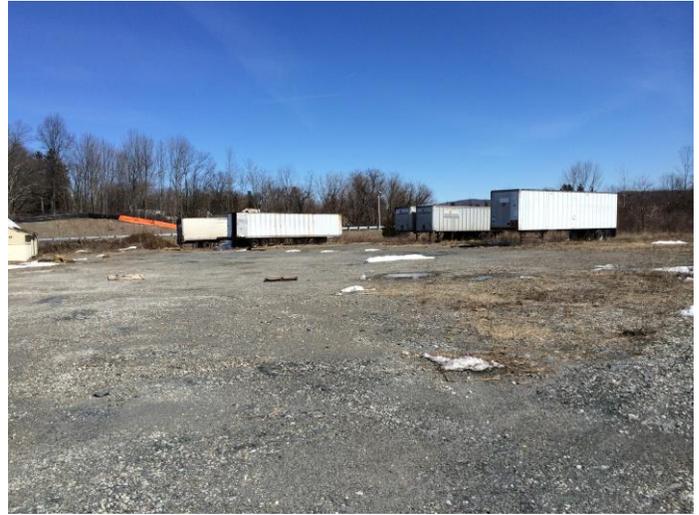
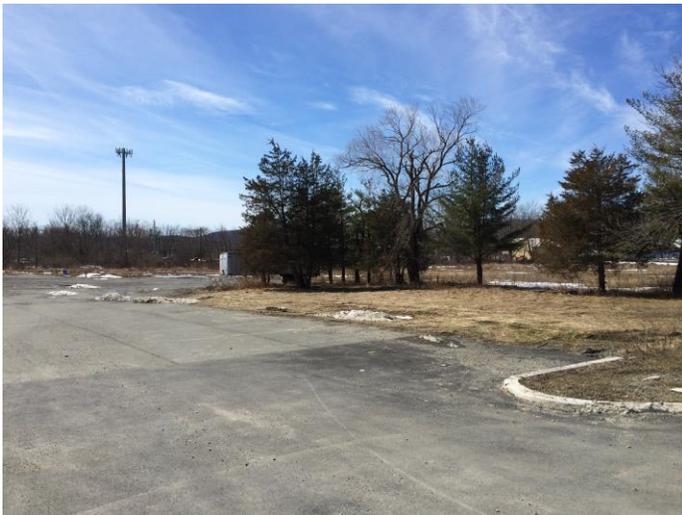
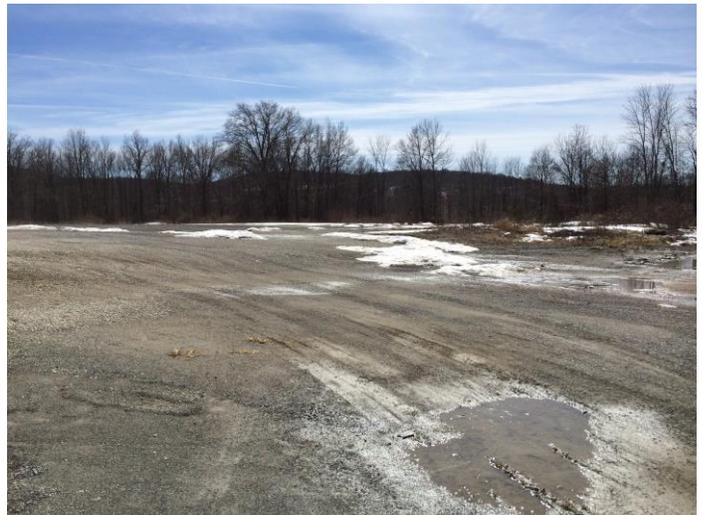
Photos 1 and 2 are looking in a southerly and westerly direction respectively. Photos 3 and 4 are looking in a northwesterly and northerly direction.

As can be seen from the photos on this page and the preceding one, the site and building conditions are in a somewhat deteriorated condition and there is a visible lack of maintenance. Much of the area used in the past for the parking and storage of trailers (and

still used as seen in photo 2) is unpaved and in a deteriorated condition and to a certain extent is unsafe for travel.

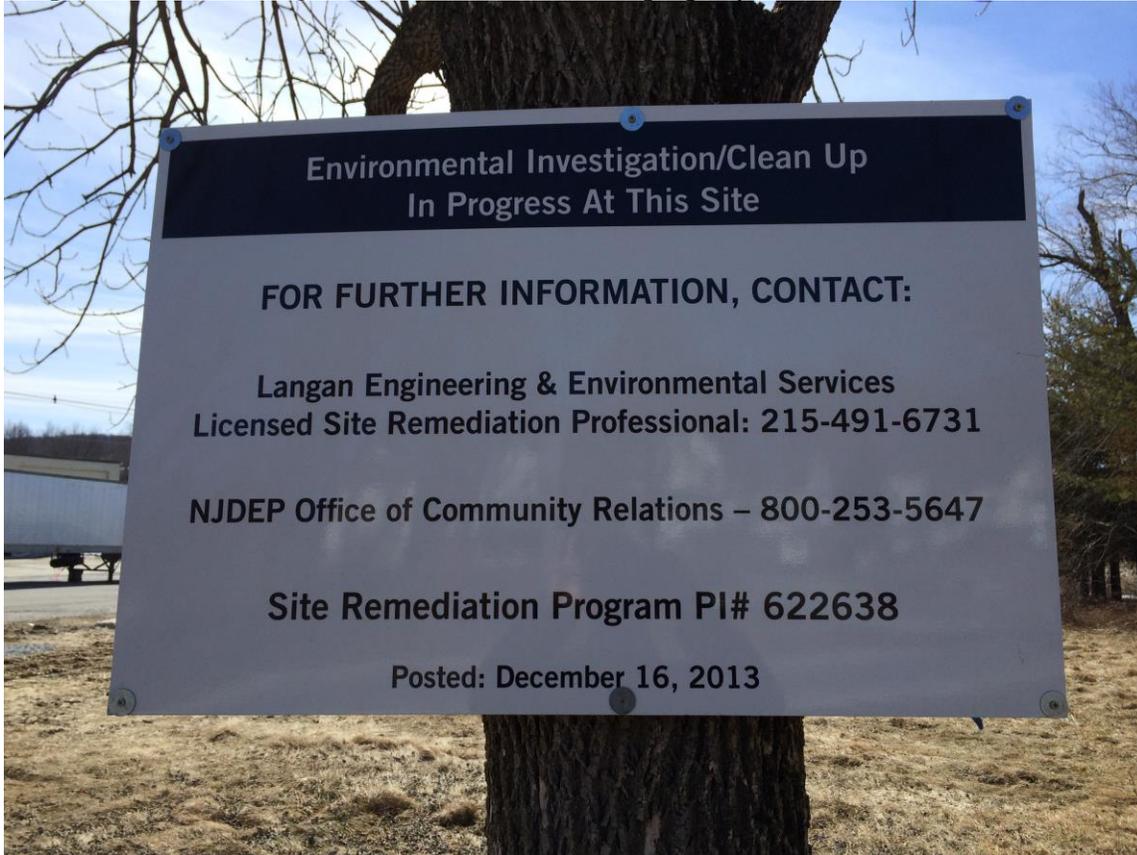
Another factor involving the site conditions associated with this property is illustrated by the photo below of a sign, which is located on the property

The issues related to the environmental investigation / cleanup advertised by this sign are discussed in detail in a memorandum report by Langan Engineering prepared for the property owner and dated 3/12/15. The findings of that report are adopted by reference and the full report can be found attached to this document. In summary, the report provides an in depth history of the property and its usage and contamination problems associated with it. The report identifies the remedial activities that have been done and are still underway. Suffice it to say, that this property has been and to a certain extent is

still constrained by environmental contamination issues but those issues are correctable and with additional effort should not be a hindrance in terms of the redevelopment of this property.

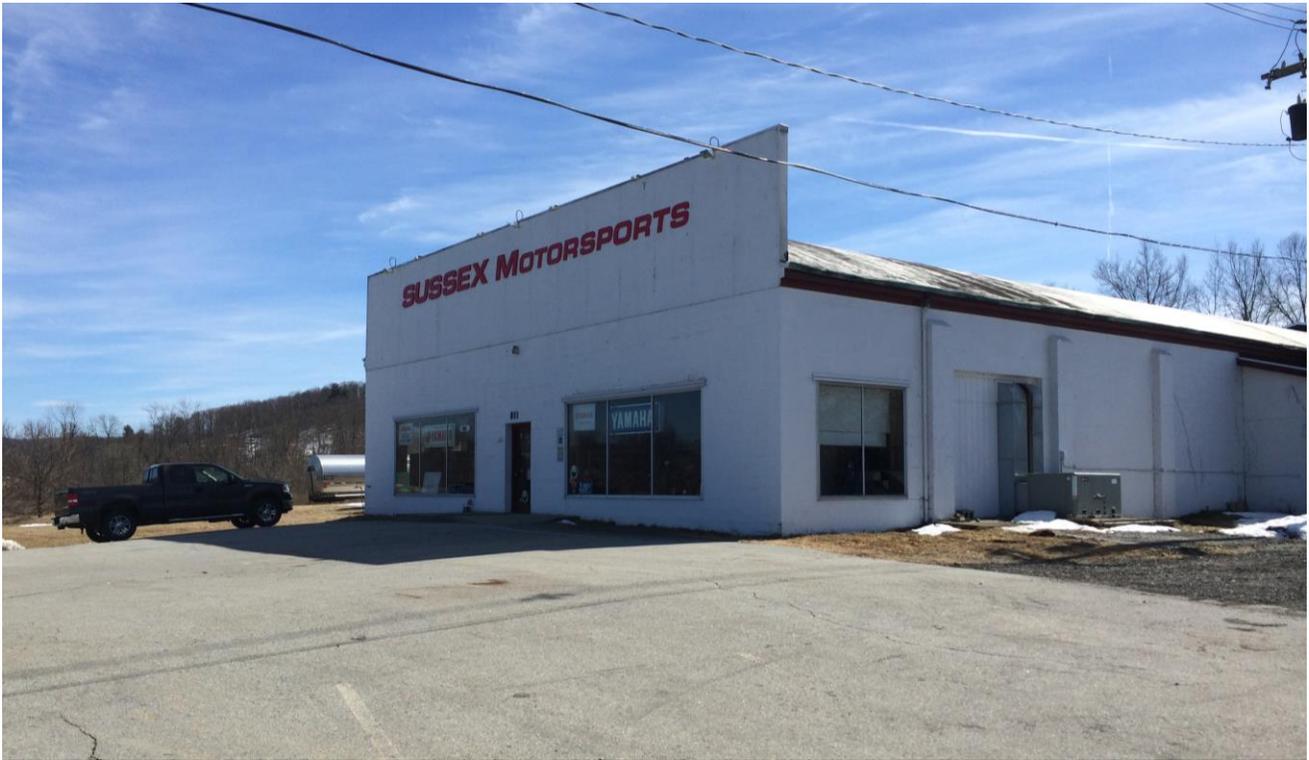
THE FRONT AND NORTH SIDE OF THE SUSSEX MOTORSPORTS BUILDING

The site is substantially underutilized and the building is setback from Route 23 an unusually long distance – nearly 200’ or more. Furthermore, although the site is large and in close proximity to Route 23, it has limited access to that roadway, as already noted. In addition, several factors related to the building on the site - constructed with obsolescent materials; a narrow, rectangular shape and how it is positioned on the site - makes its expansion and / or renovation problematic, based on current building and site design standards.

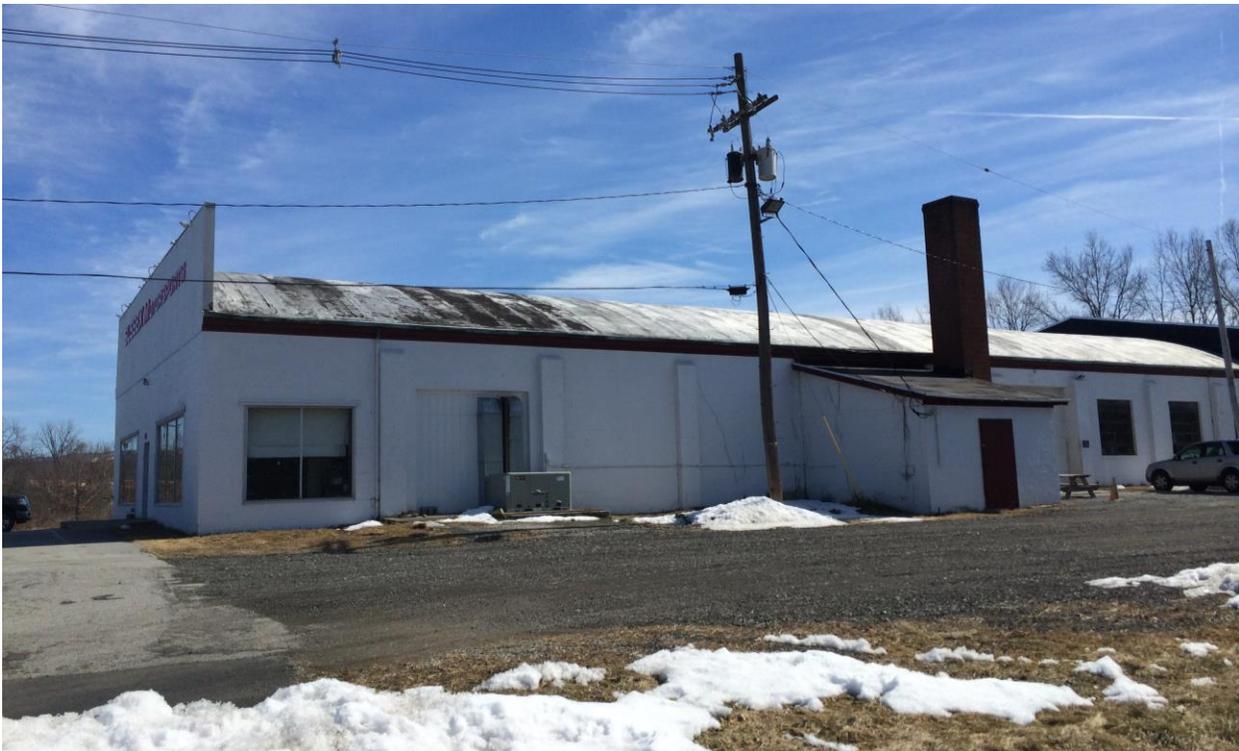
THE ENTIRE NORTH SIDE OF THE SUSSEX MOTOTRSPORTS BUILDING

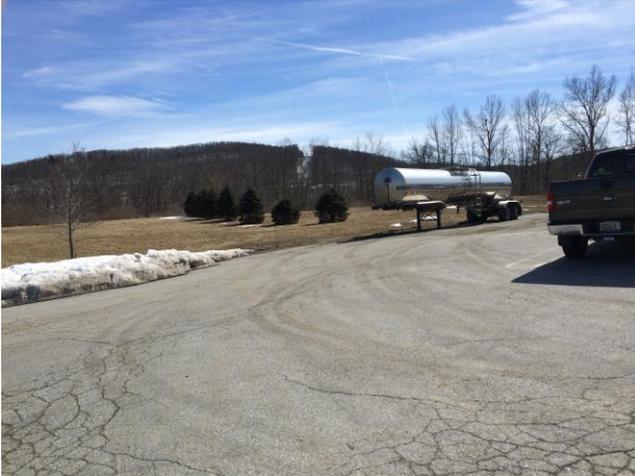
LOOKING TOWARD THE SOUTH

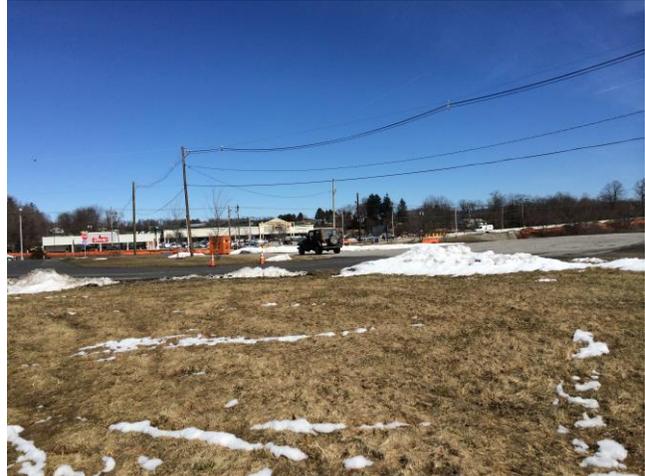
LOOKING TOWARD THE EAST AND ROUTE 23

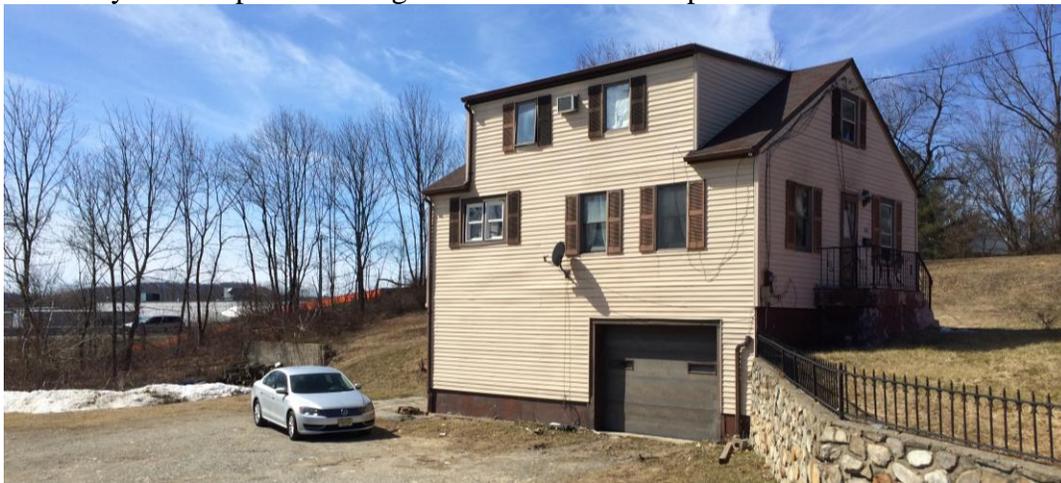
The property accommodates a one and a half story, single family, Cape Cod style residential structure, with a garage underneath, and the remnants of one or more accessory structures. The residence consists of 1,335 sq ft. It was difficult to determine the exact age of the structure but it appears to be of mid 20th century vintage. However, based on an exterior inspection of the structure, there is some evidence that the existing residence may have been an expansion of an earlier structure that occupied the site. The structure is in fair condition but there is evidence of some detrioraion and neglect, particularly with respect to siding and roof issues.– see photos that follow

LOOKING NORTHWEST FROM ROUTE 23 NORTHBOUND

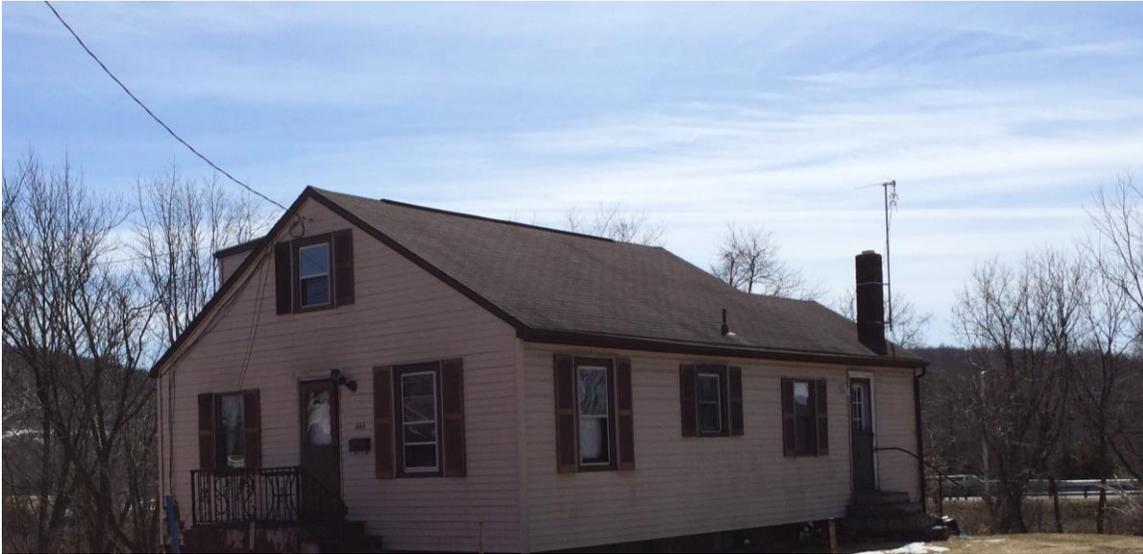
LOOKING SOUTHWEST FROM ROUTE 23 NORTHBOUND

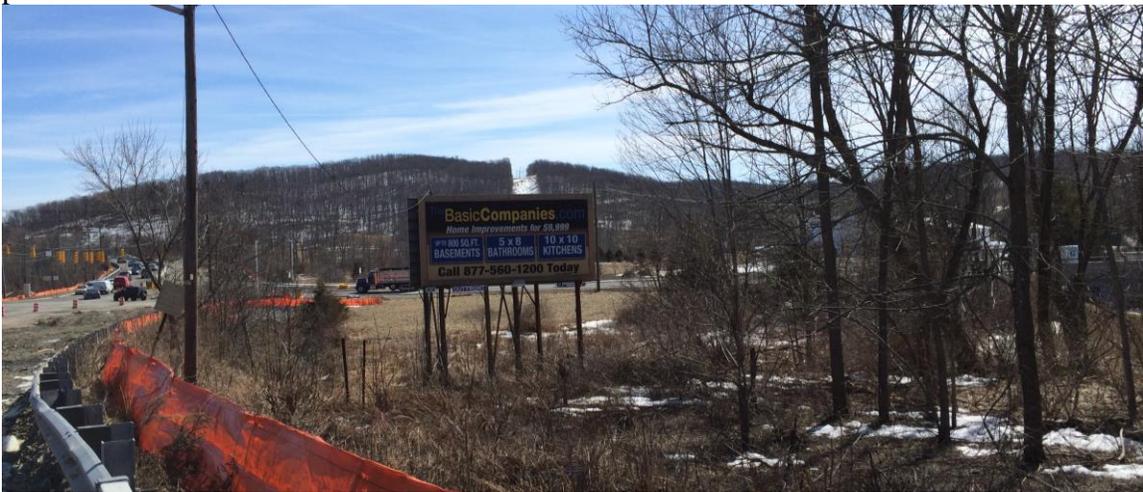
The property also accommodates a billboard – see photo below. The billboard appears to be in good condition and is actively utilized. In the vicinity of the billboard and to the west of the residence, a small wetland area is evident, which imposes constraints on the future development potential of the site, as well as accessibility. Access to the site is primarily from Route 23 Northbound. Although the site fronts on both Route 23 Northbound and Southbound, it is doubtful that NJDOT will allow any access to this site from Route 23 Southbound and any expanded access from Route 23 Northbound may be problematic as well.

LOOKING SOUTH FROM ROUTE 23 NORTHBOUND TOWARD BILLBOARD

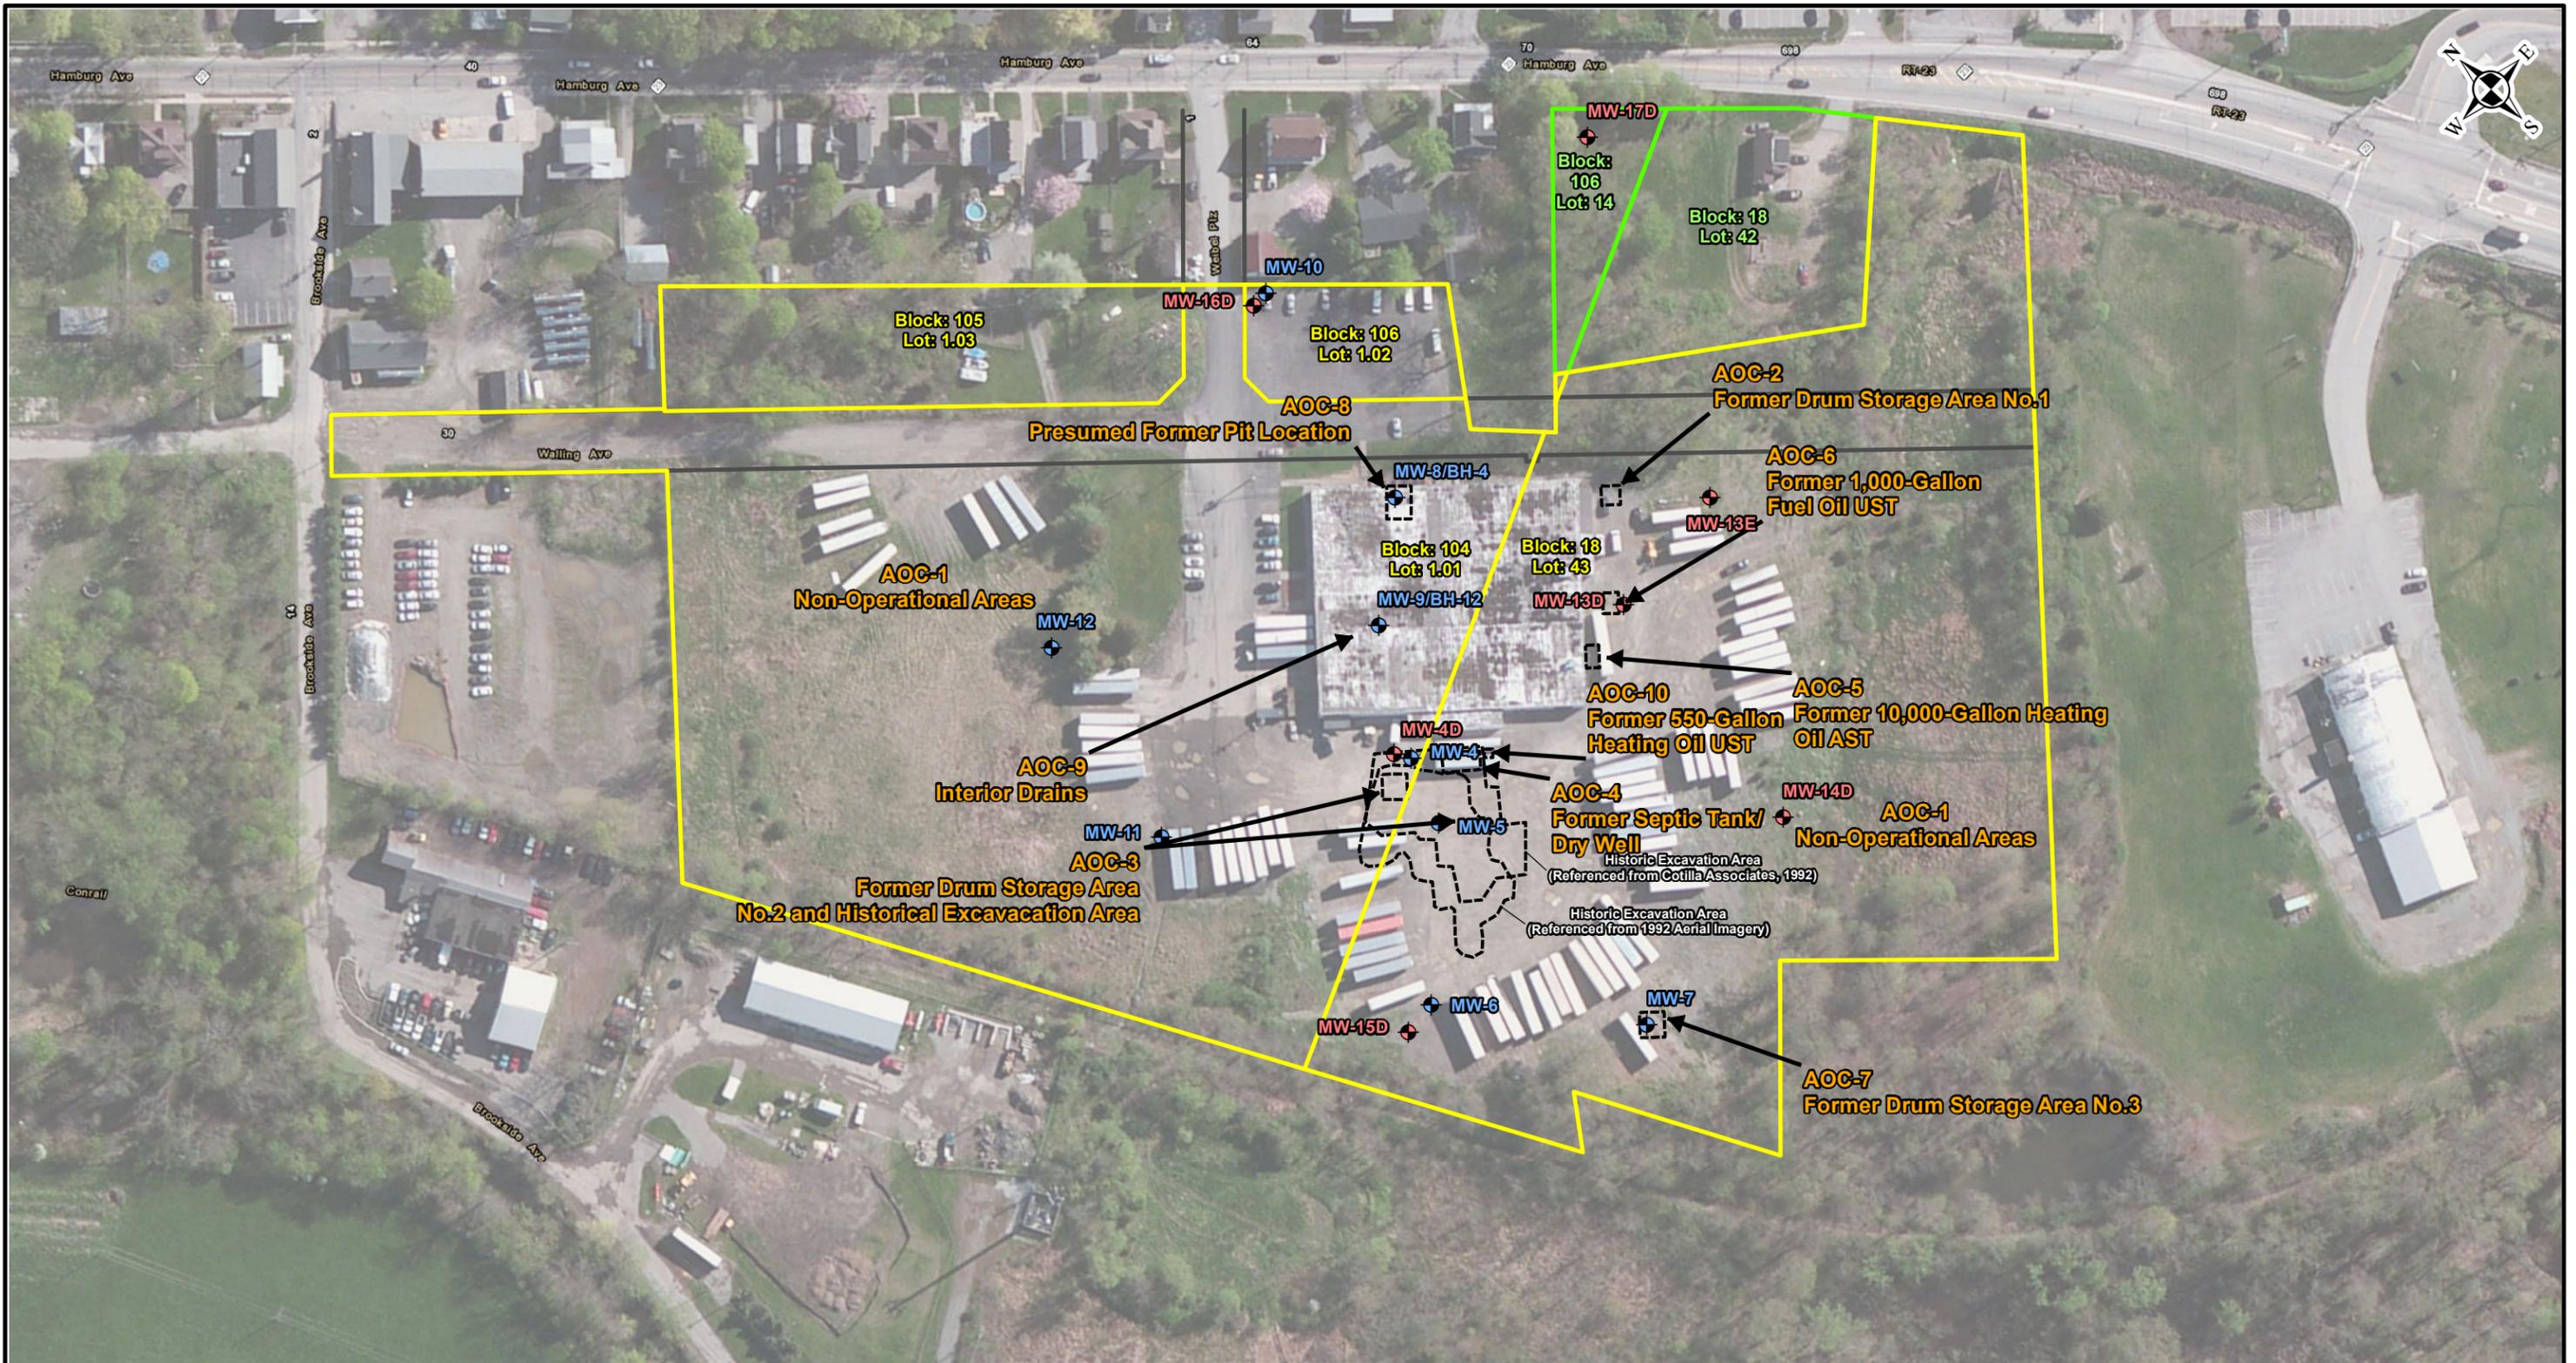
AREA OF CONCERN MAP

- Bedrock Monitoring Well Location
- Overburden Monitoring Well Location
- Property Boundary
- Off-Site Properties
- Right of Way
- Approximate AOC Extent

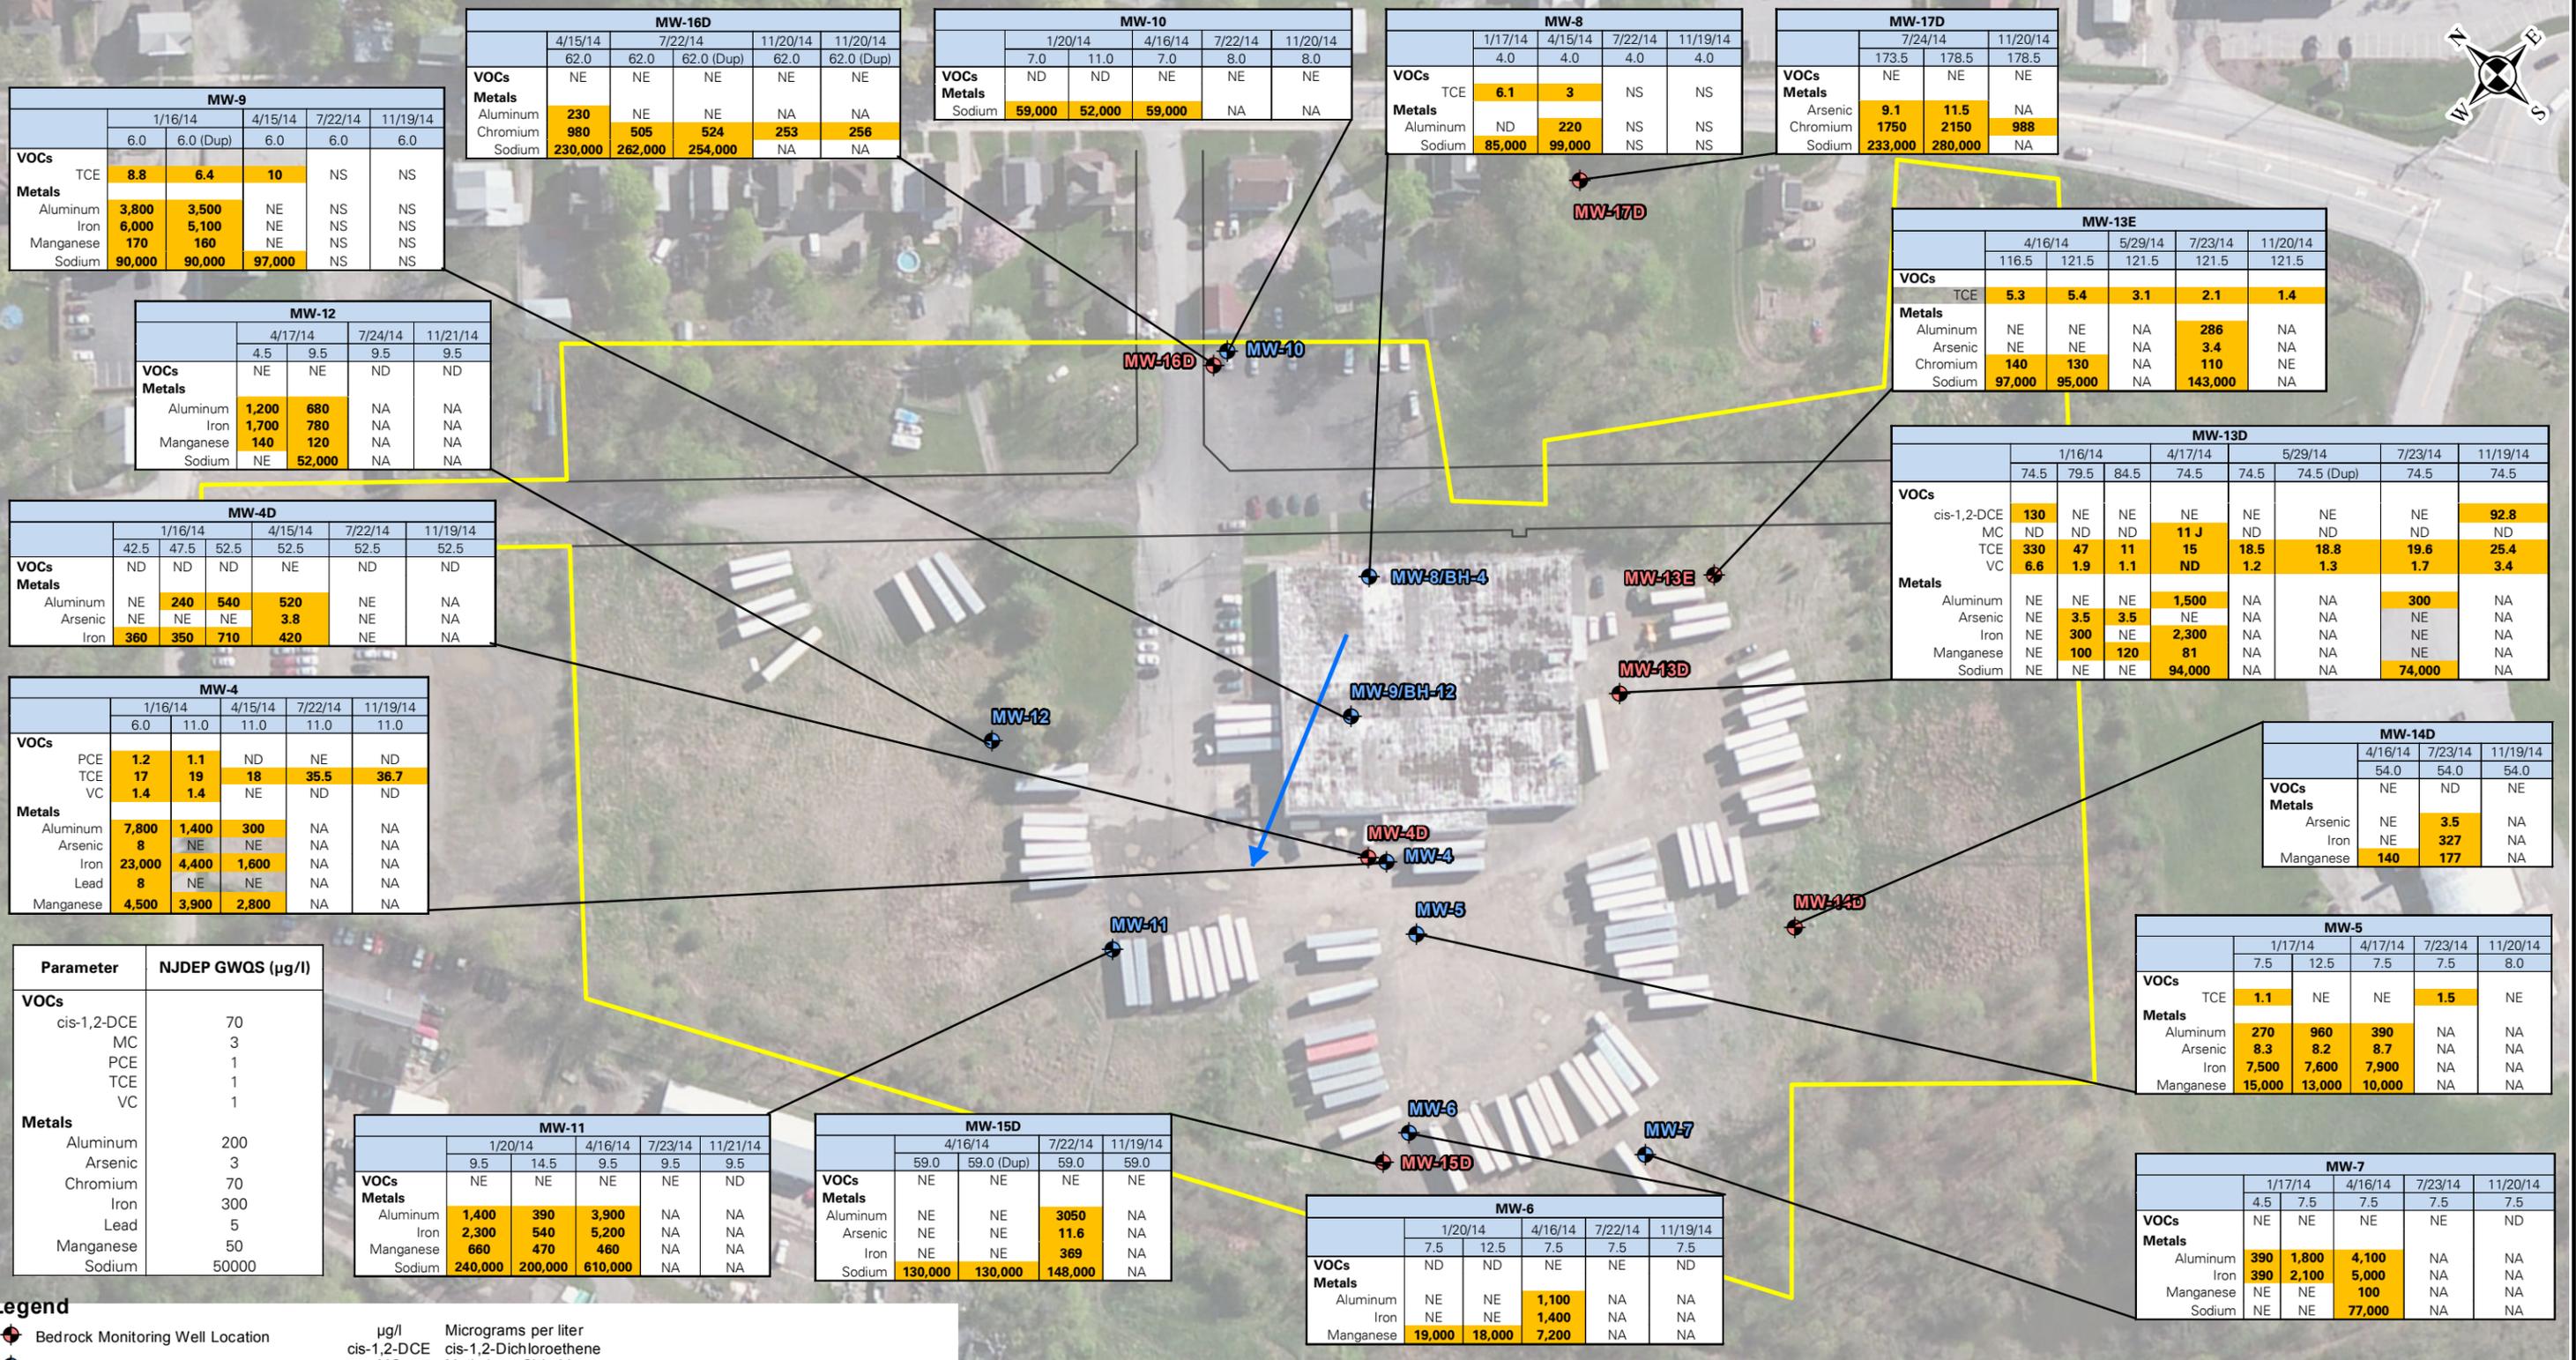
Drawing Title
GROUNDWATER SAMPLING LOCATION AND RESULTS PLAN 2014

MW-9					
	1/16/14	4/15/14	7/22/14	11/19/14	
VOCs	6.0	6.0 (Dup)	6.0	6.0	6.0
TCE	8.8	6.4	10	NS	NS
Metals					
Aluminum	3,800	3,500	NE	NS	NS
Iron	6,000	5,100	NE	NS	NS
Manganese	170	160	NE	NS	NS
Sodium	90,000	90,000	97,000	NS	NS

MW-16D					
	4/15/14	7/22/14	11/20/14	11/20/14	
VOCs	62.0	62.0	62.0 (Dup)	62.0	62.0 (Dup)
Metals					
Aluminum	230	NE	NE	NA	NA
Chromium	980	505	524	253	256
Sodium	230,000	262,000	254,000	NA	NA

Notes:
 1. World aerial imagery basemap is provided through Langan's Esri ArcGIS software licensing and ArcGIS online. Source of aerial imagery is Microsoft from 20110320. Credits: Esri, DigitalGlobe, GeoEye, i-cubed, USDA, USGS, AEX, Getmapping, Aerogrid, IGN, IGP, and the GIS User Community
 2. All concentrations are in micrograms per liter (µg/l).
 3. Results noted for only those compounds which have been detected and exceed their respective NJDEP GWQS
 4. Unable to sample monitoring wells MW-8 and MW-9 during July and November 2014 quarterly sampling event due to low water table.
