**A PRELIMINARY INVESTIGATION
REGARDING
THE DESIGNATION
OF
A PROPOSED AREA IN NEED OF
REDEVELOPMENT**

***THE ROUTE 23
REDEVELOPMENT
AREA***

PREPARED BY:
THE NELSON CONSULTING GROUP
2 VOLCANIC HILL ROAD
WANTAGE, NEW JERSEY
973 875 8685

APRIL 30 ,2015

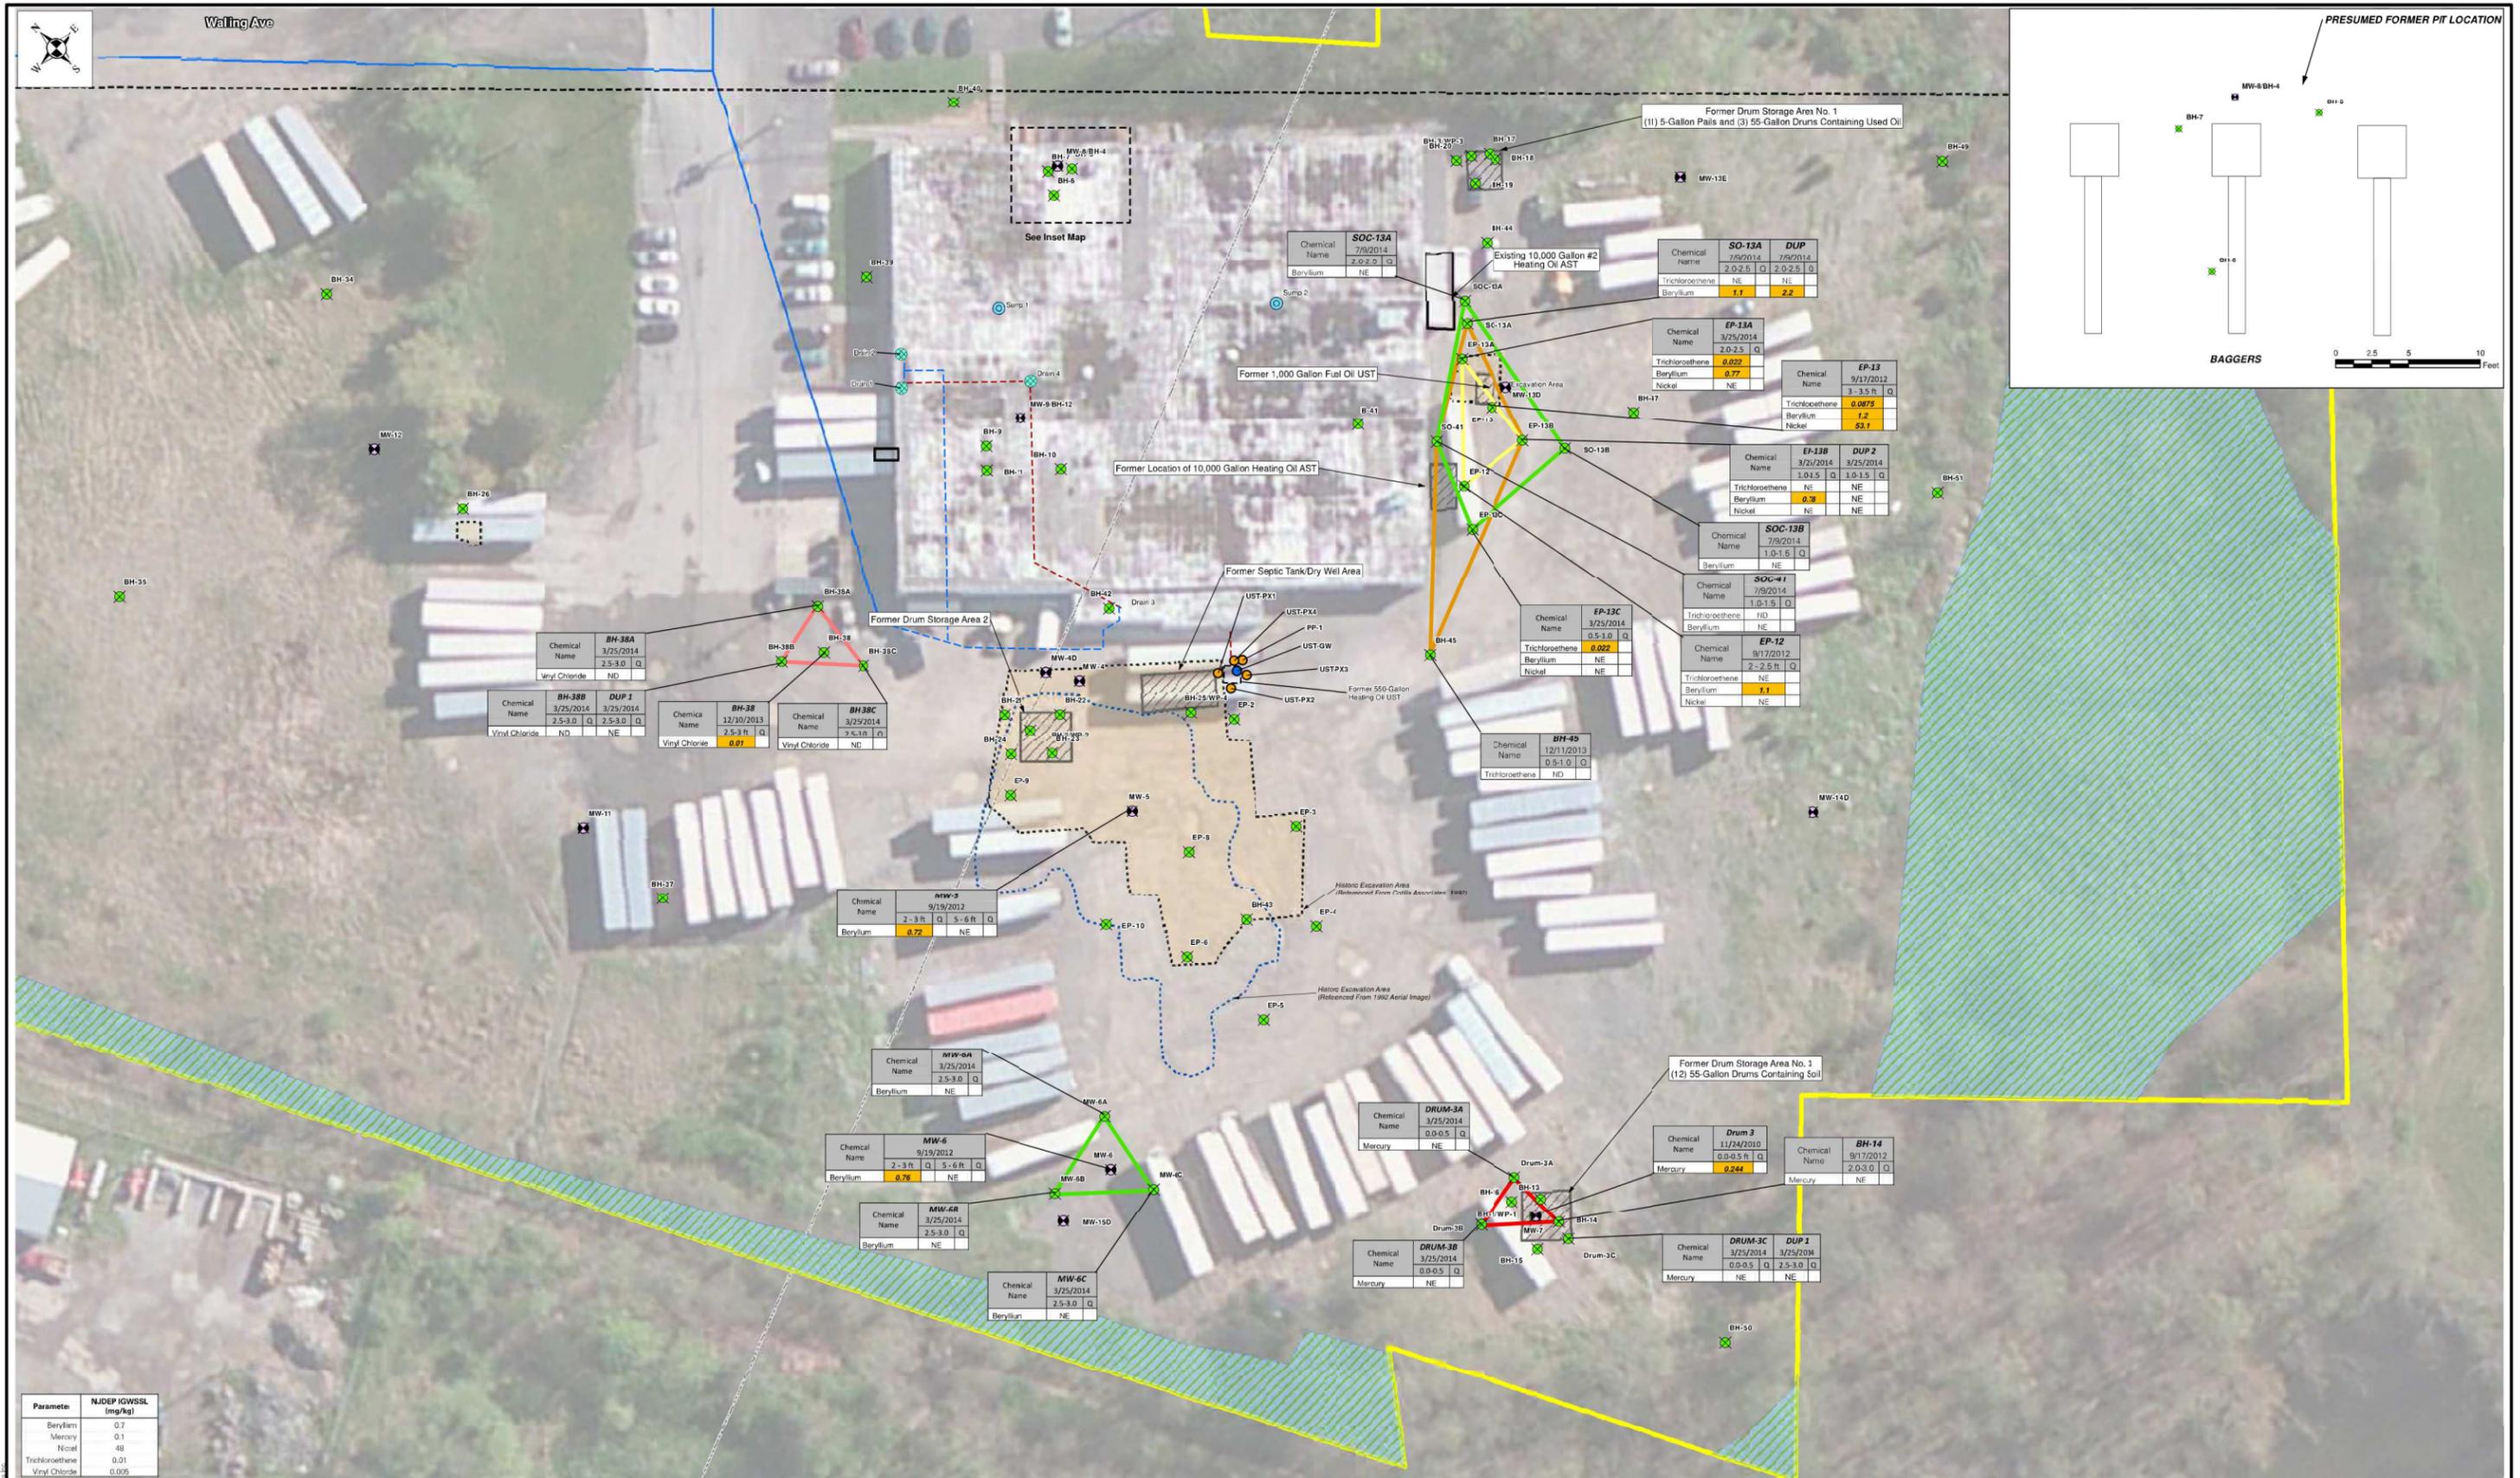
Project No. 240031501
 Date 12/12/2014
 Scale 1"=120'
 Drawn By BJS
 Figure 2

- Langan identified that overburden and bedrock groundwater at the Site is impacted with low levels of CVOCs which were detected above their respective GWQs. Figure 2 attached to this memorandum depict the monitoring well locations and the groundwater analytical results that have been detected above their respective GWQs.

Drawing Title
GROUNDWATER SAMPLING LOCATION AND RESULTS PLAN 2014
